**Conditions Assessment
of the
Old Firehouse/Freewill Baptist Church
Huntington Center**

Prepared by
Eliot Hays Lothrop
Building Heritage, LLC

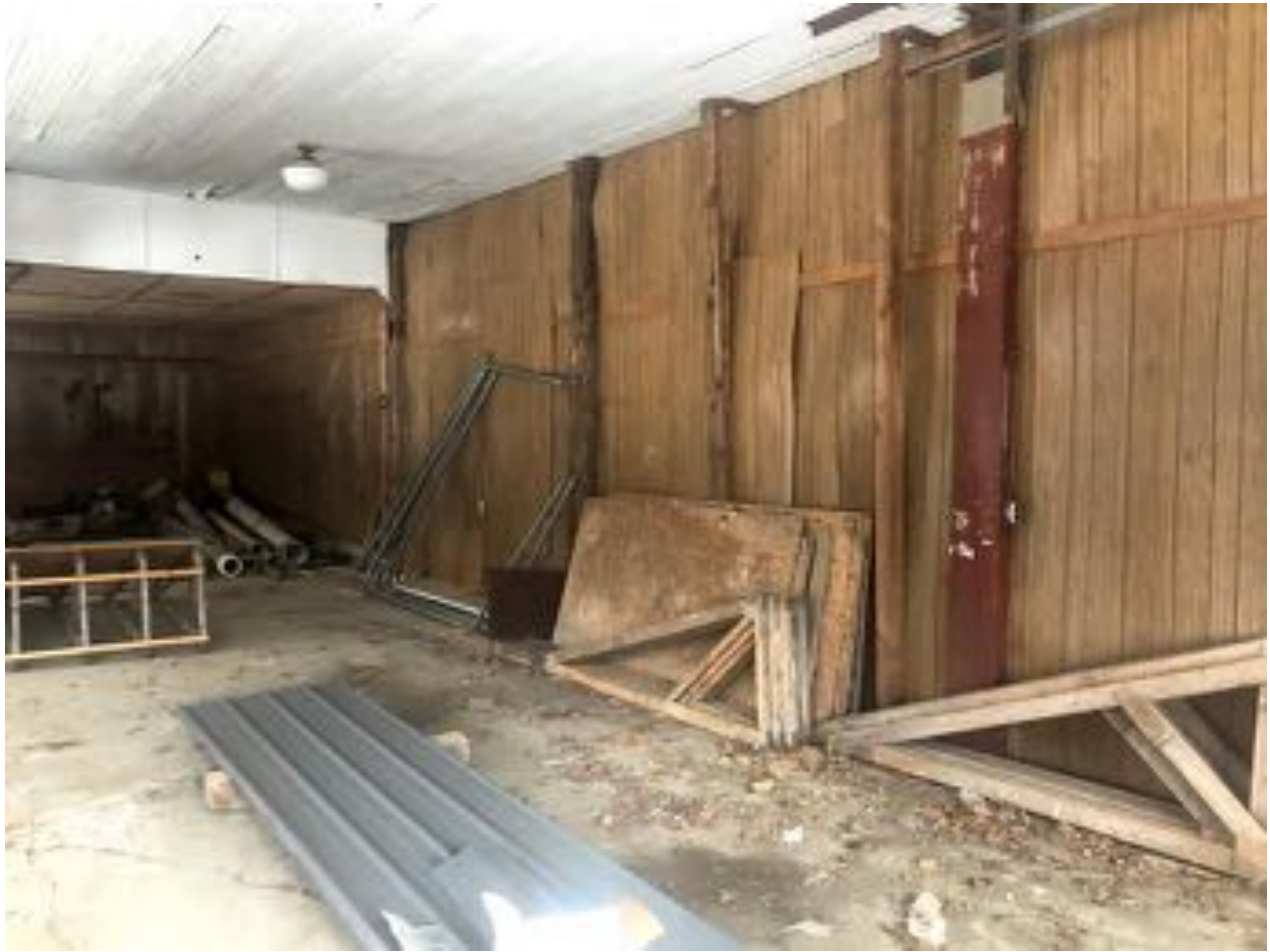
Interior of the building, with three posts exposed, the first of which is shown with its apparently original casing, still intact. The top of the post casing is cut to a convex curve on the two sides, which suggests that the original ceiling was coved. The other two posts are bare and have empty mortises at varying heights, suggesting that they are re-used material from an earlier frame.

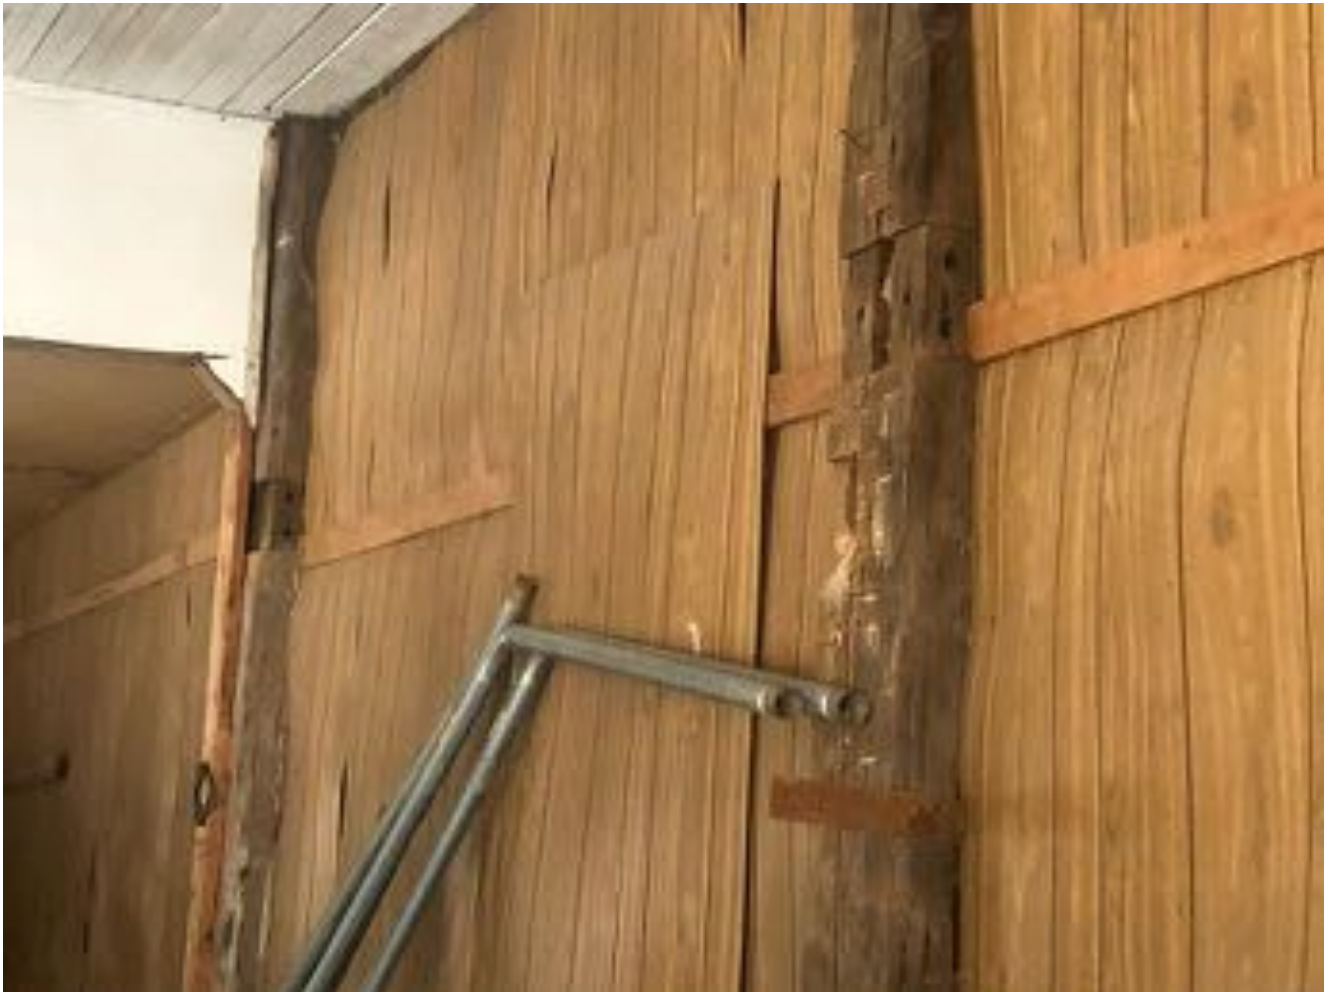
Timber posts in the Northwest corner, with empty mortises at different heights which suggest they were originally cut for a different structure. The post in the foreground shows brace mortise, below the large mortise on the inside face. In its current orientation, the housing indicates that that brace would be descending into the interior of the space, which is unlikely. Empty mortises throughout, indicate that most of the timbers were re-used from what appears to have been a full two story tall building based on the post mortises. The original joinery was cut using the square rule, demonstrated by the housings at the mortises. This method of layout was widespread by 1800.

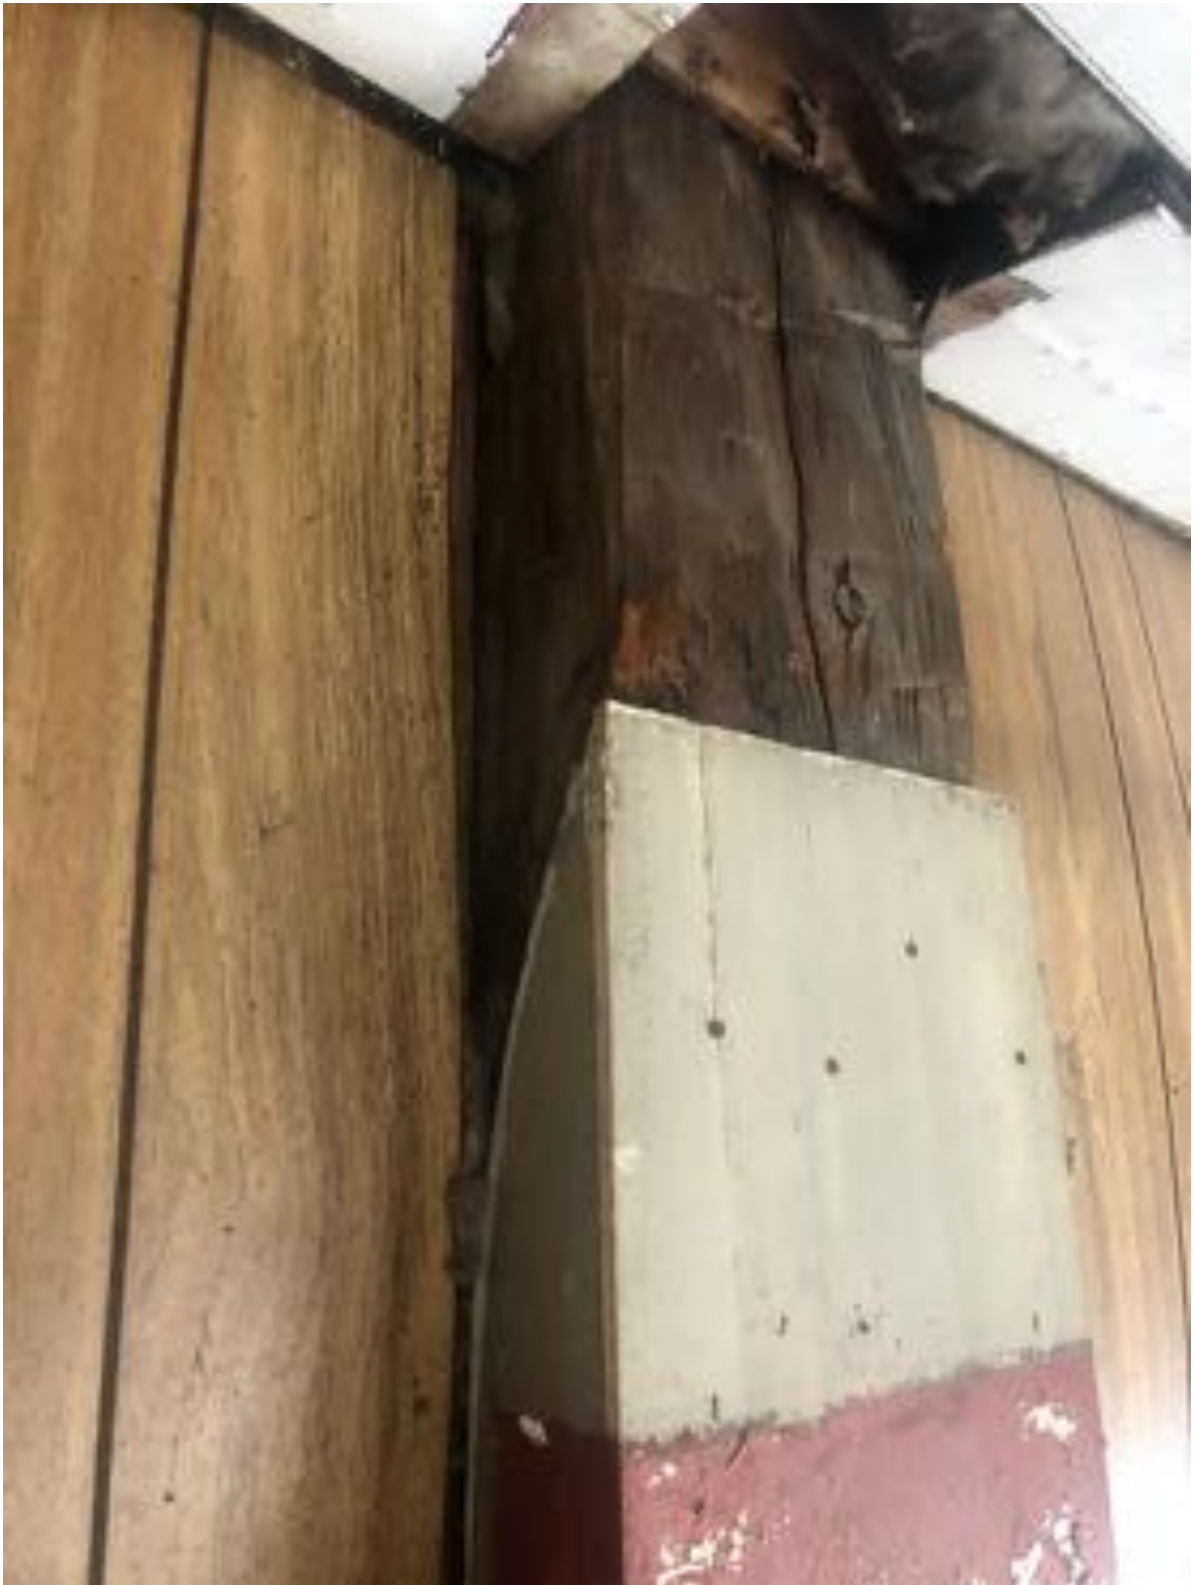
Post casing, showing the steep coved ceiling that was likely original to the church. Removal of the newer beadboard ceiling should uncover the top of this curve.

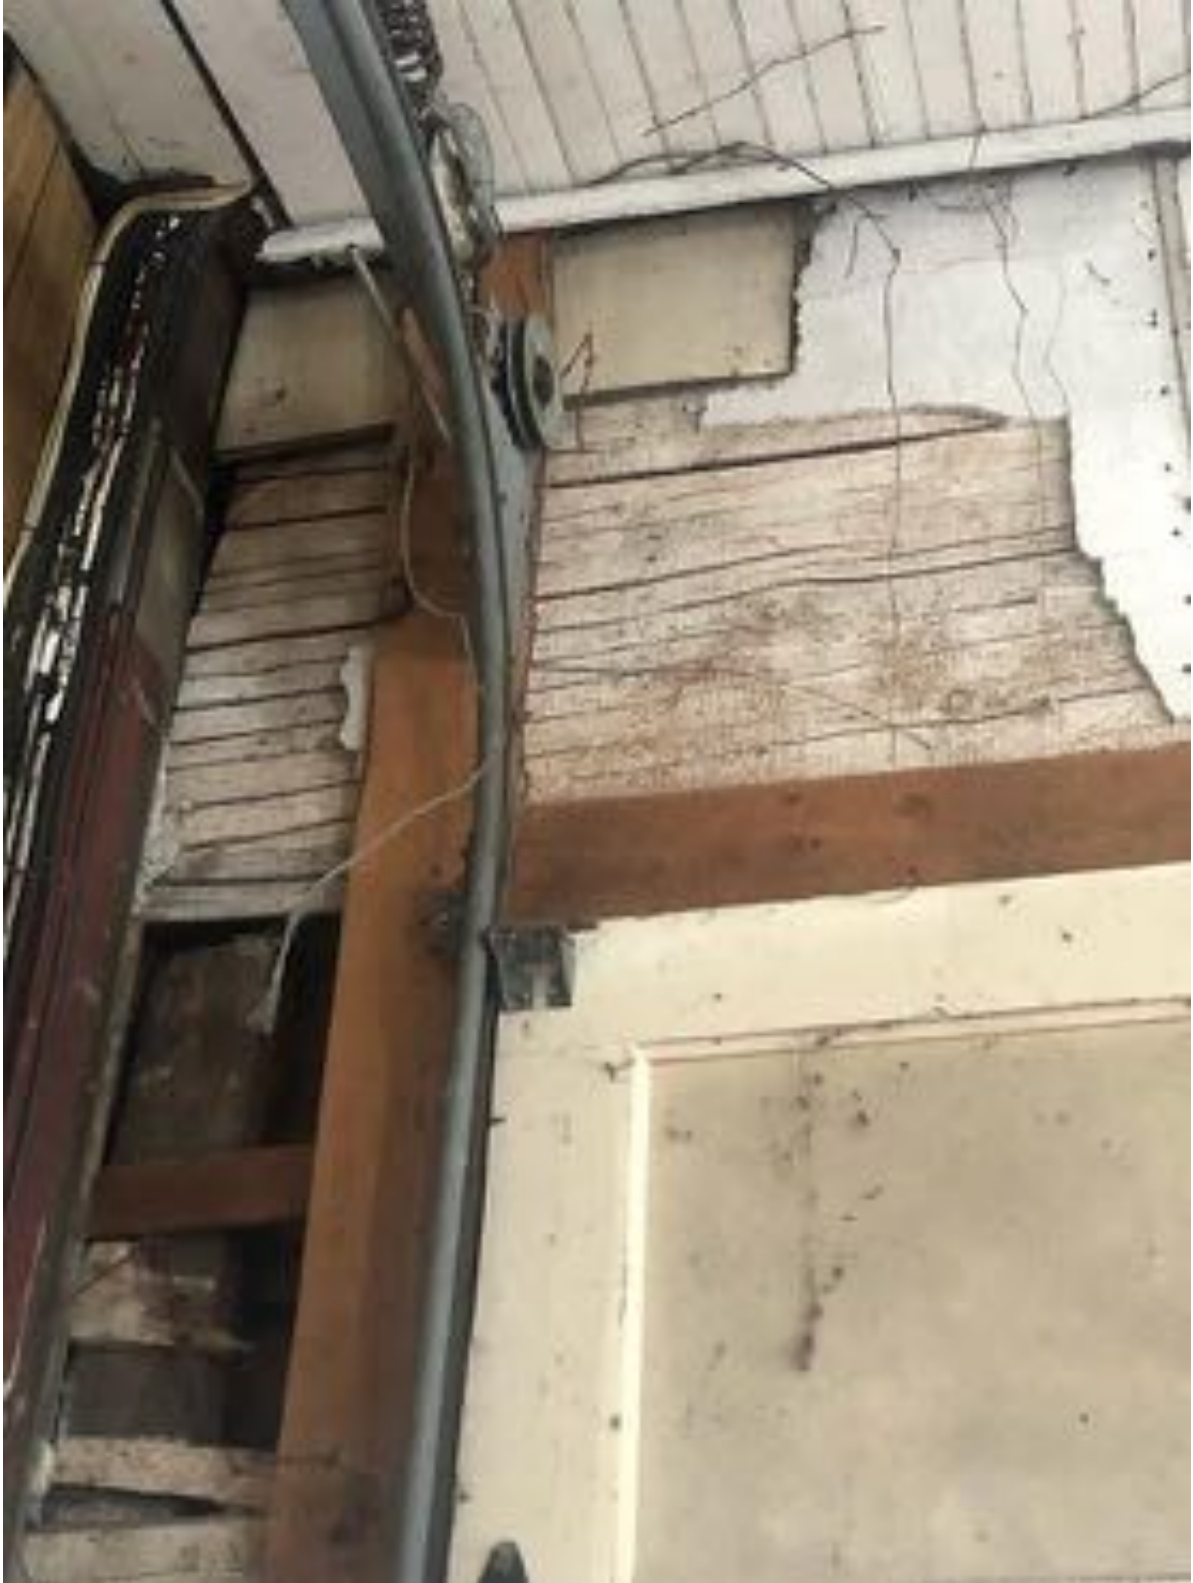
A small section of split lathe and plaster that was uncovered behind the 1980's paneling. Cut lathe replaced split lathe around 1850, so this section of wall predates that transition and is likely original to the structure.

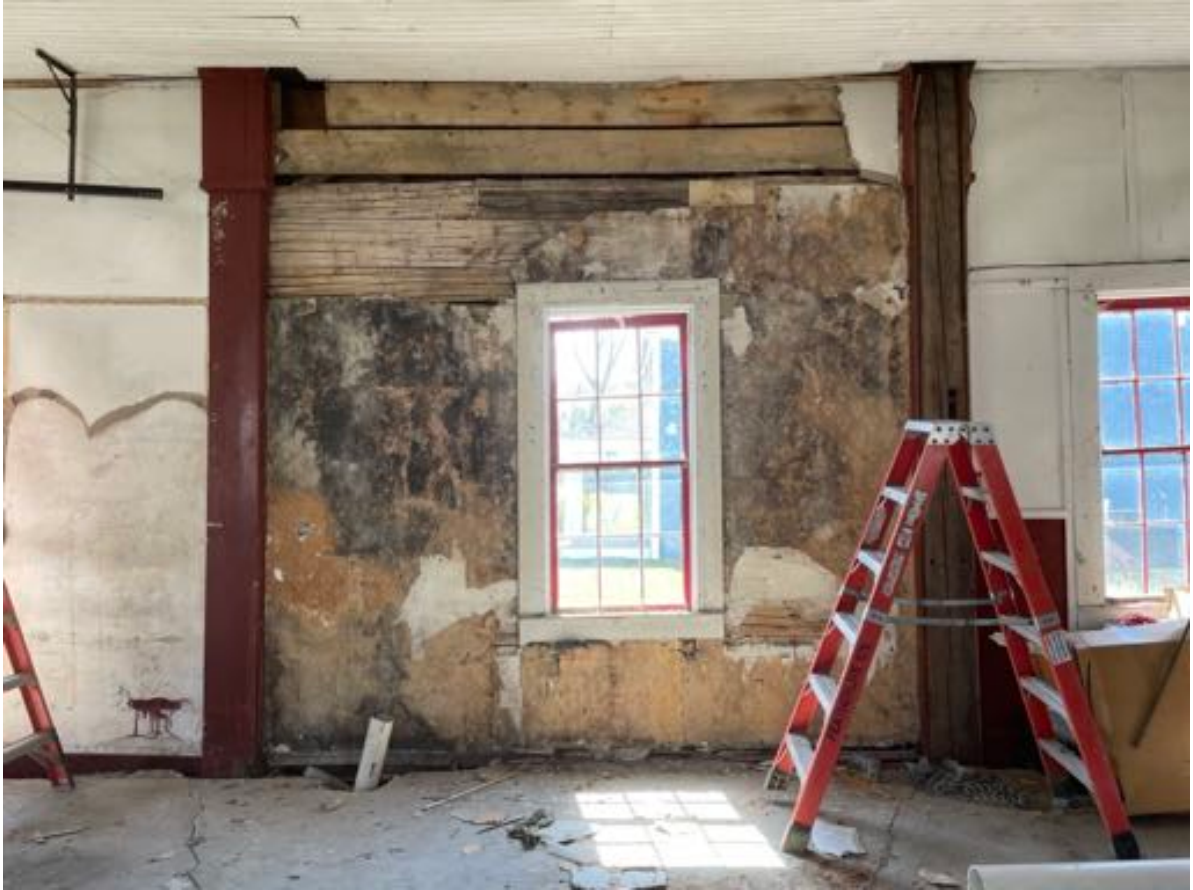
The south side of the building with the interior paneling removed at a recent work party to reveal original lathe and plaster. The boards at the top of the middle bay were added when the paneling was installed to fasten the paneling to. Before that, the coved ceiling would have sprung from the wall plane but this was removed. More evidence of that cove is likely still intact on the gable ends, where the paneling has not yet been removed.

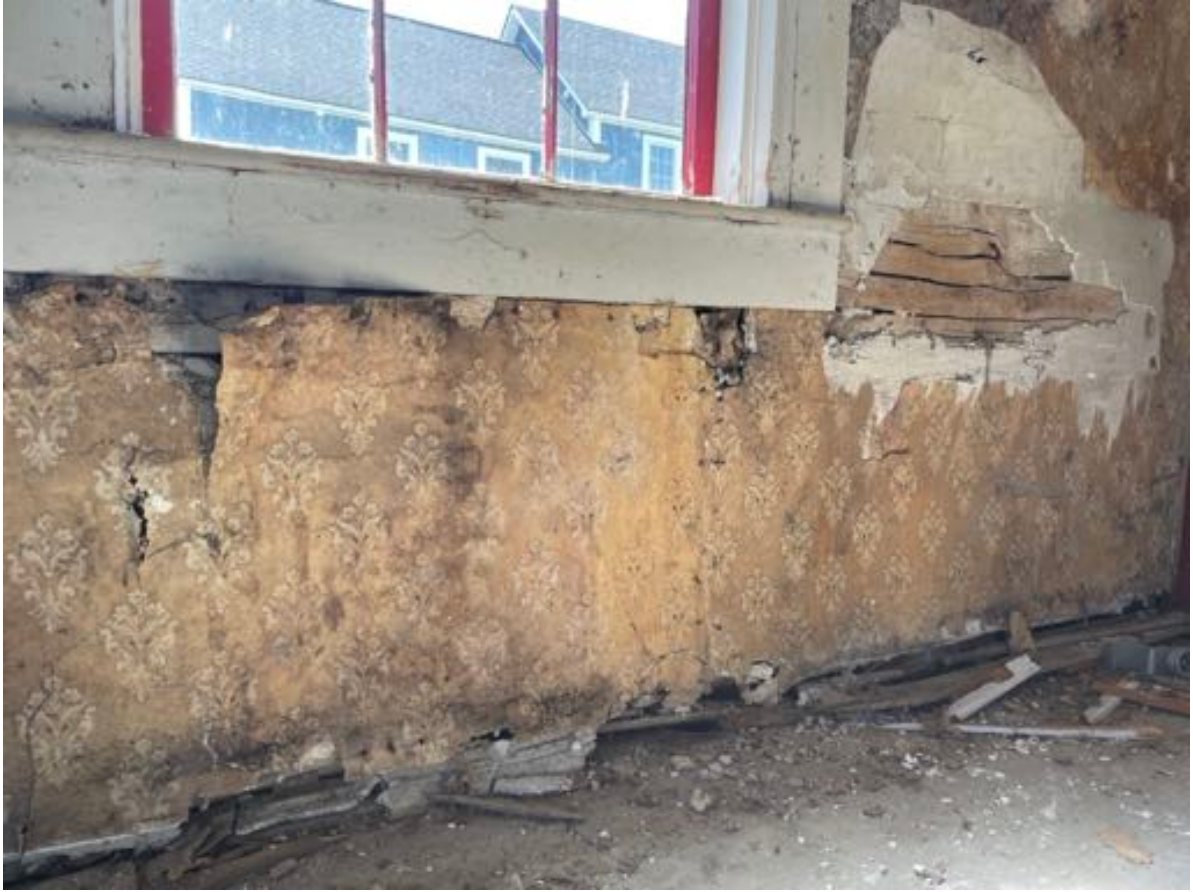
Split lathe and plaster, covered by wallpaper . The window trim and portions of the baseboard are still intact.

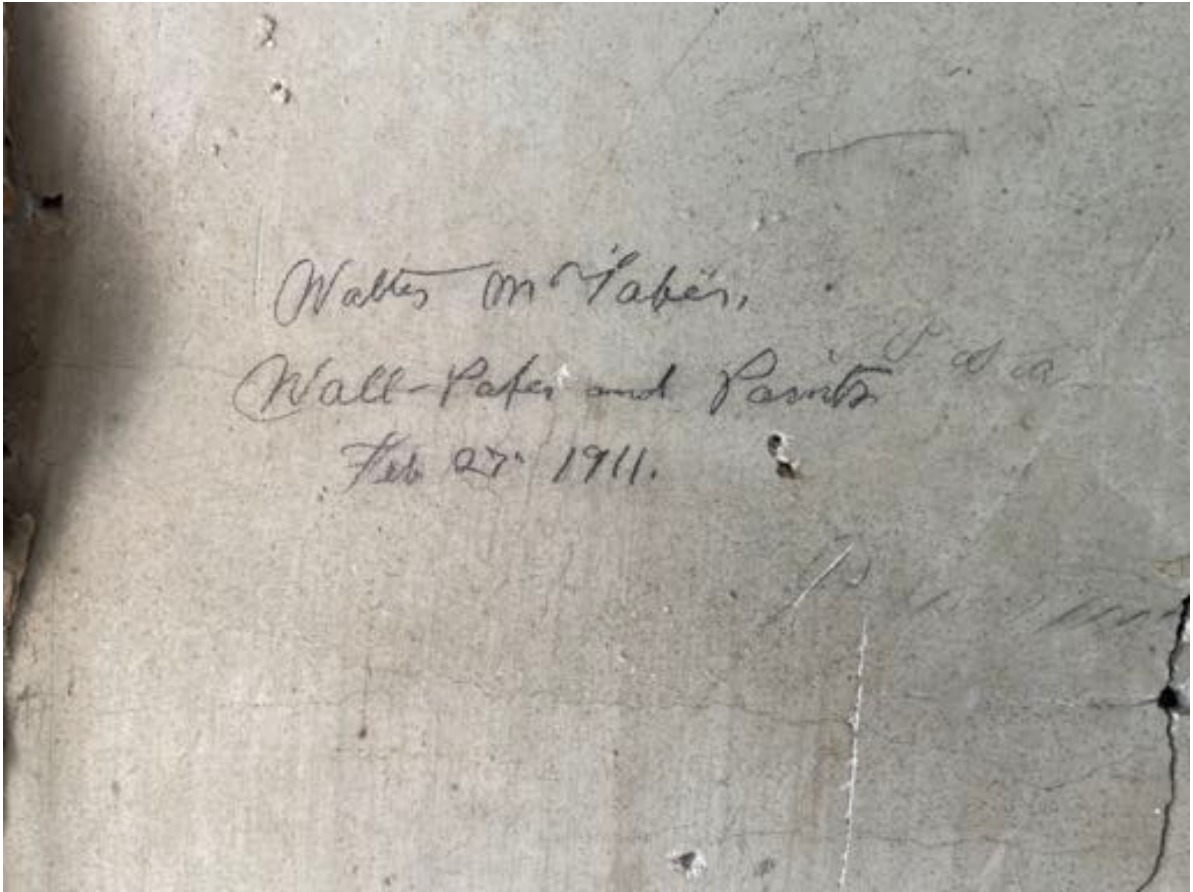
One of the many signatures found on the uncovered plaster wall. Dating to the painting and wallpapering in 1911 apparently.

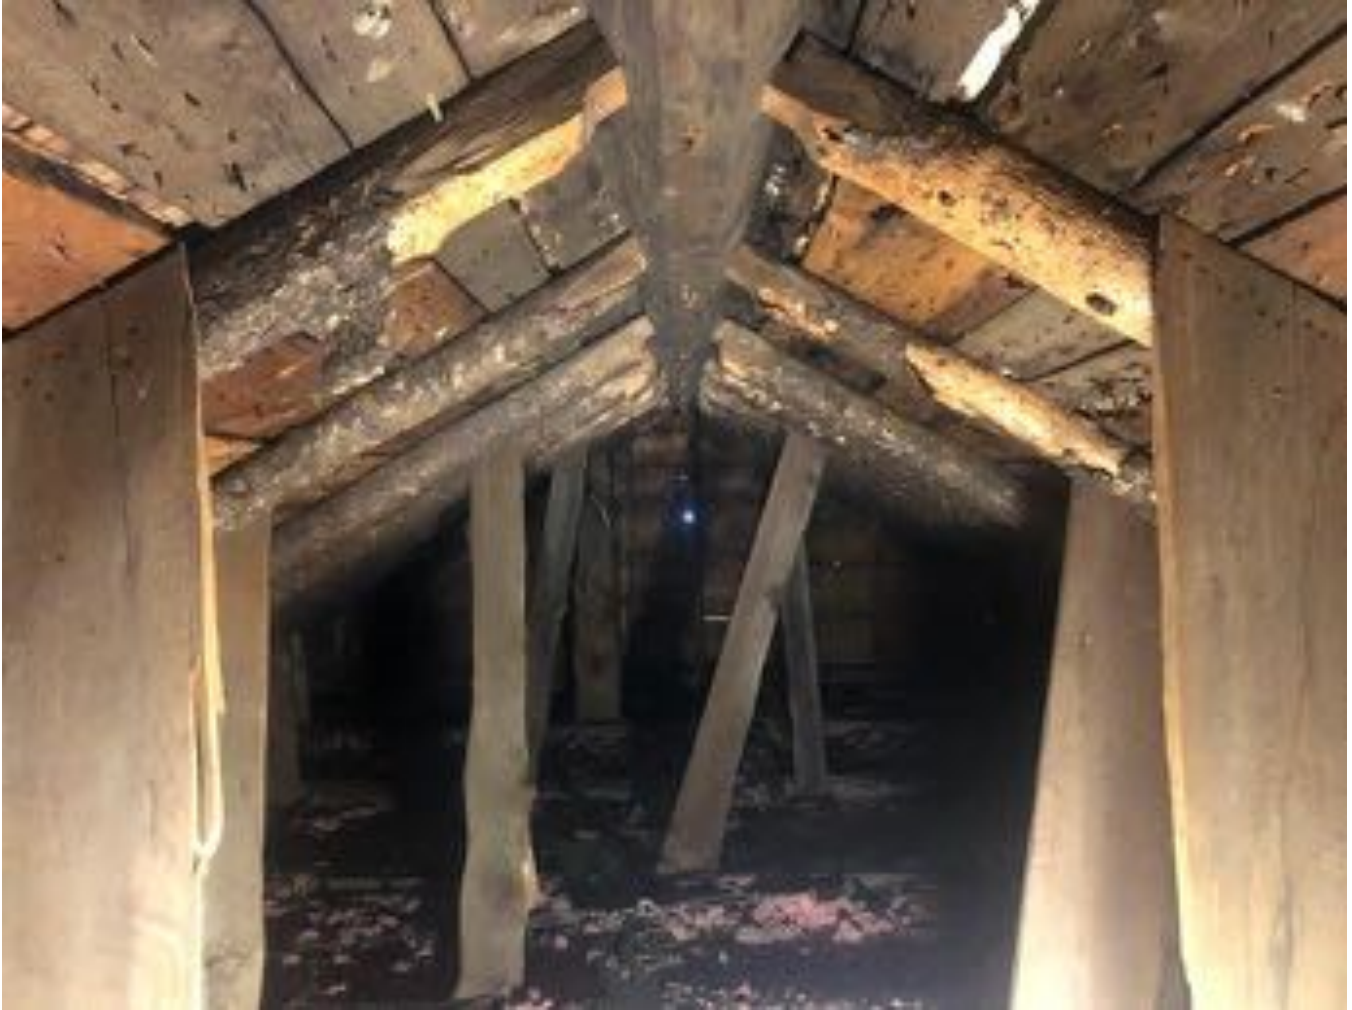
A continuous five-sided ridge beam connects the half round spruce rafters at their peak. The bark was left on the rafters, suggesting that they were cut in the winter, when park needs to be peeled off of the logs with a drawknife and was often overlooked in the interest of a speedy raising. The applied cleats appear to be original and were used as a makeshift truss, hanging the tie beams or bottom chord off of the rafters. The engineering behind this is problematic however and doesn't really work without a tension connection at the end of the rafters.

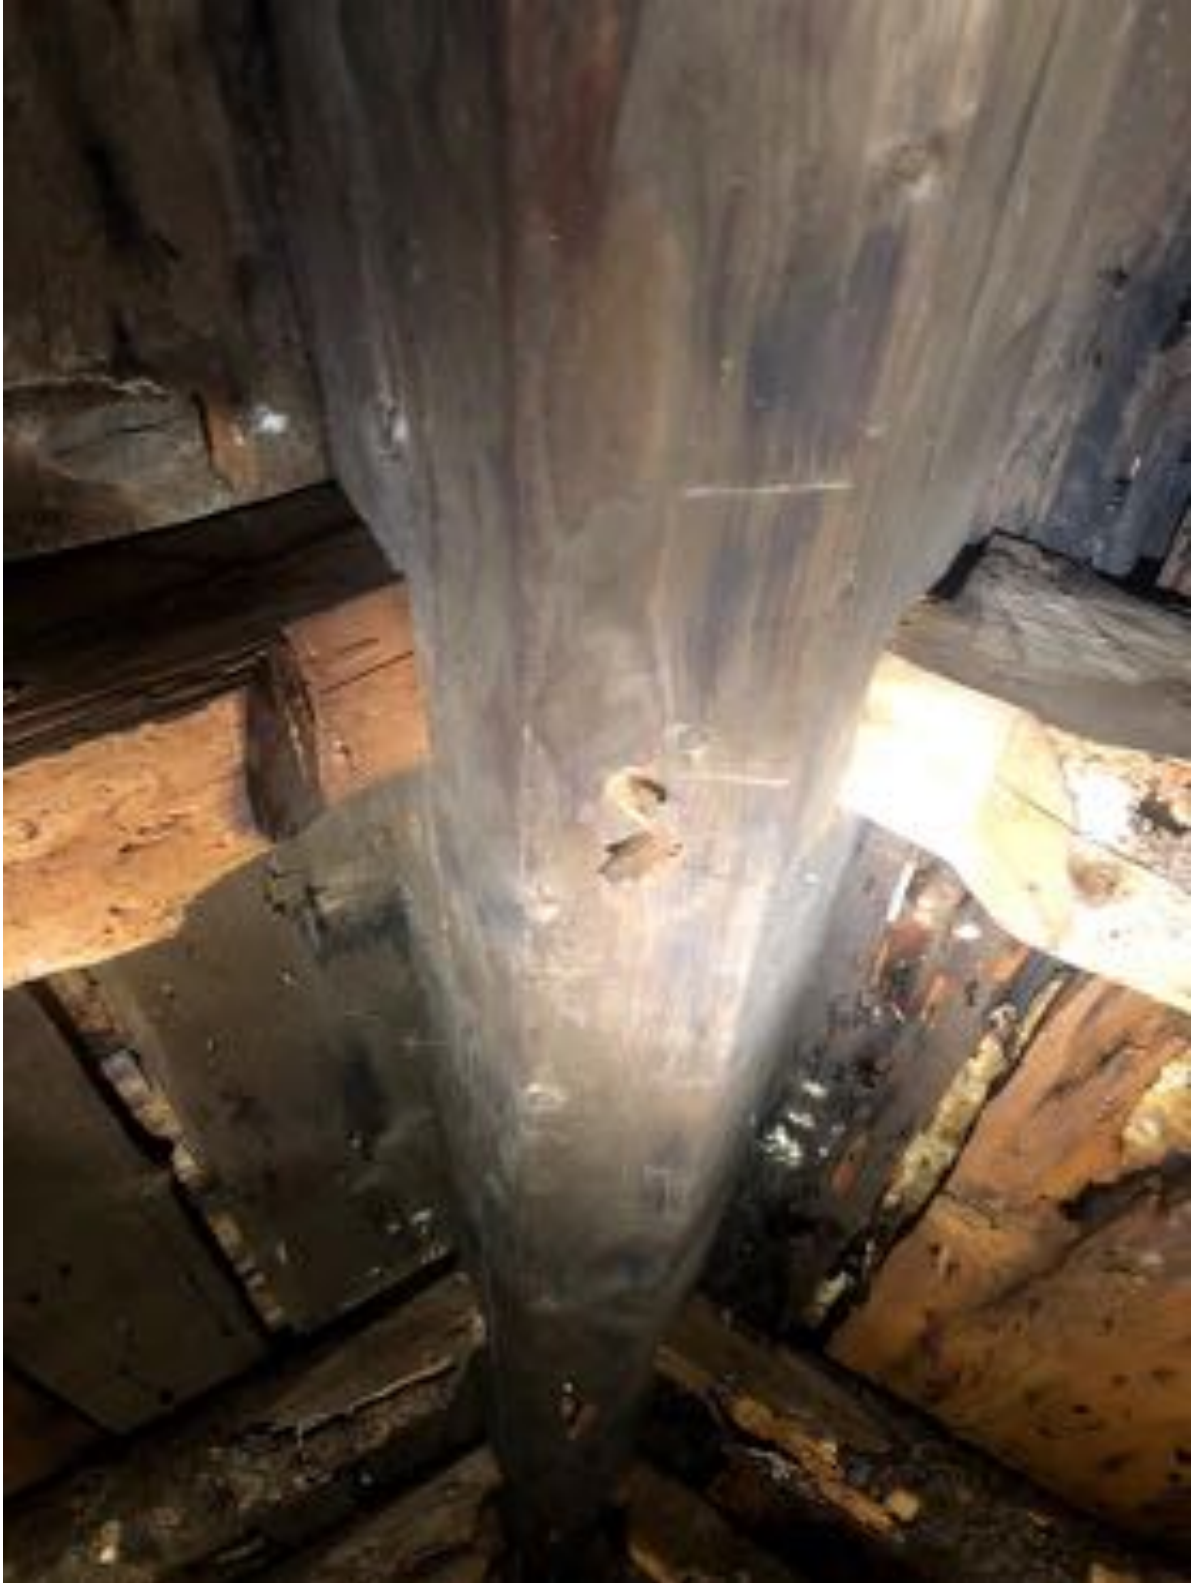
Another inconclusive detail that would support this is the five sided ridge beam, which the rafters tenon into at their peak. When sighting down the length of the ridge beam, it appears that it is asymmetrical, possibly due to poor hewing. The South bearing face of the ridge beam is square to the roof system but the North side is shallower than square, something that they would have had to compensate for in the peak cut on the rafters in order to make the joint tight. The rafters themselves are half round spruce poles, flatted on the top for the roof sheathing and left in the round, with the bark on in the interior. They are notched into the top plates with an uncommon step lap detail, in which the heel is locked into the plate by way of a plumb, rather than square, step lap and then pegged on the downhill slope square to the roof. The combination of the plumb cut and square peg angle lock the heel of the rafter into the plates incredibly well, likely to prevent uplift of the roof at its eaves. While this is not a common detail, I have seen several other structures in Huntington that utilize it as well.

Close up of the five-sided ridge and rafters. It appears that the geometry of the hewing is off slightly with the South side being slightly steeper than a square angle to the roof, which is the typical design. This is likely an error in the layout of the hewing .

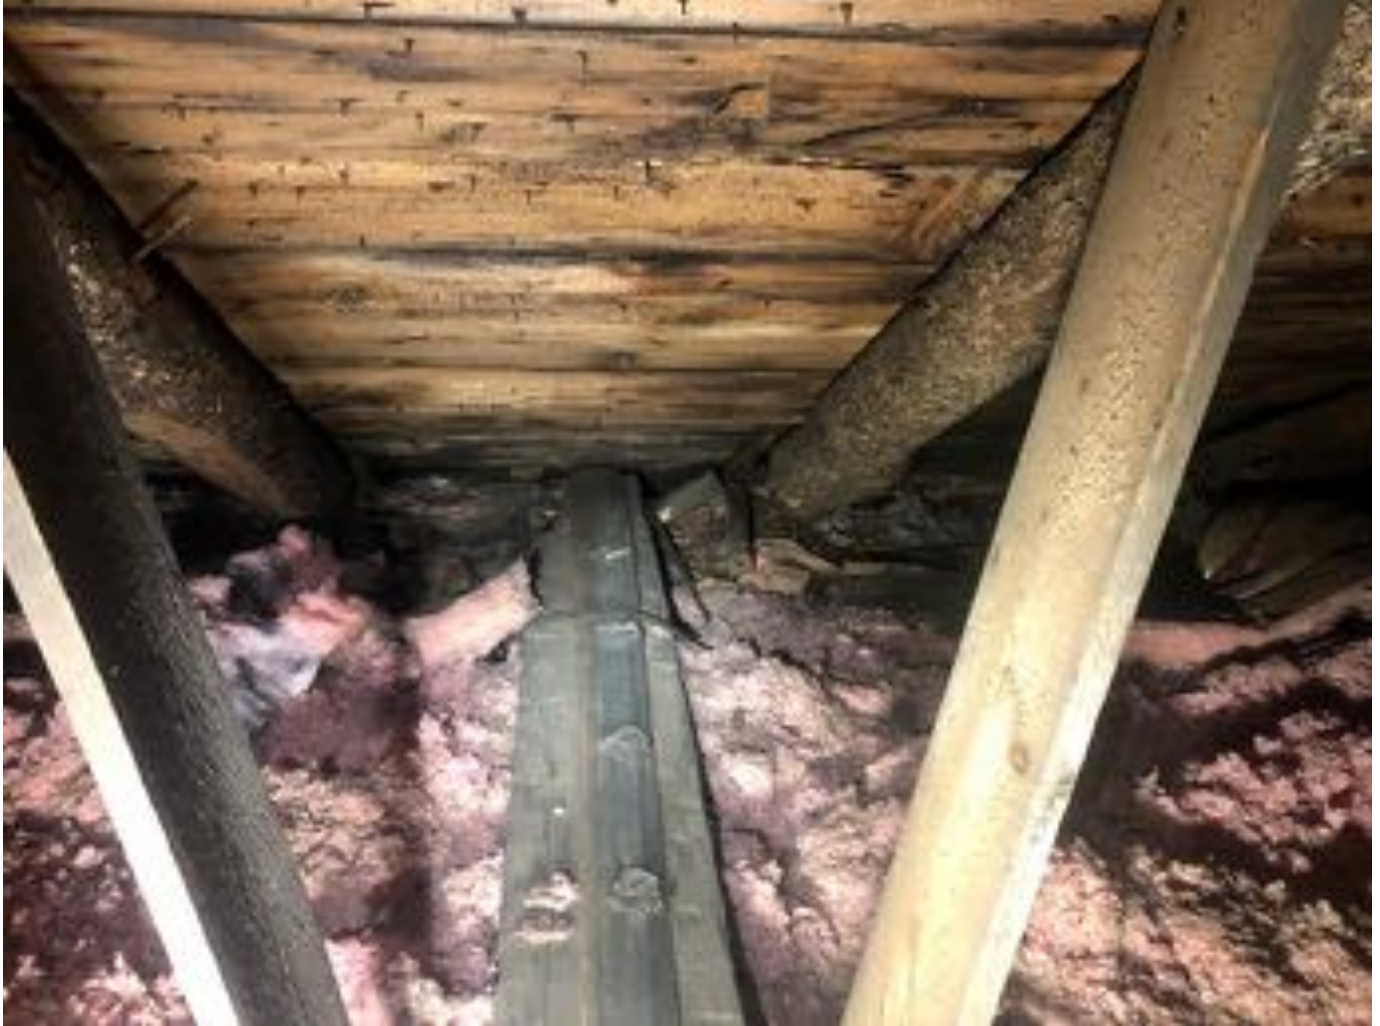
Cutting edge from a plow attached to the top of tie beam three on the South end for reinforcement.

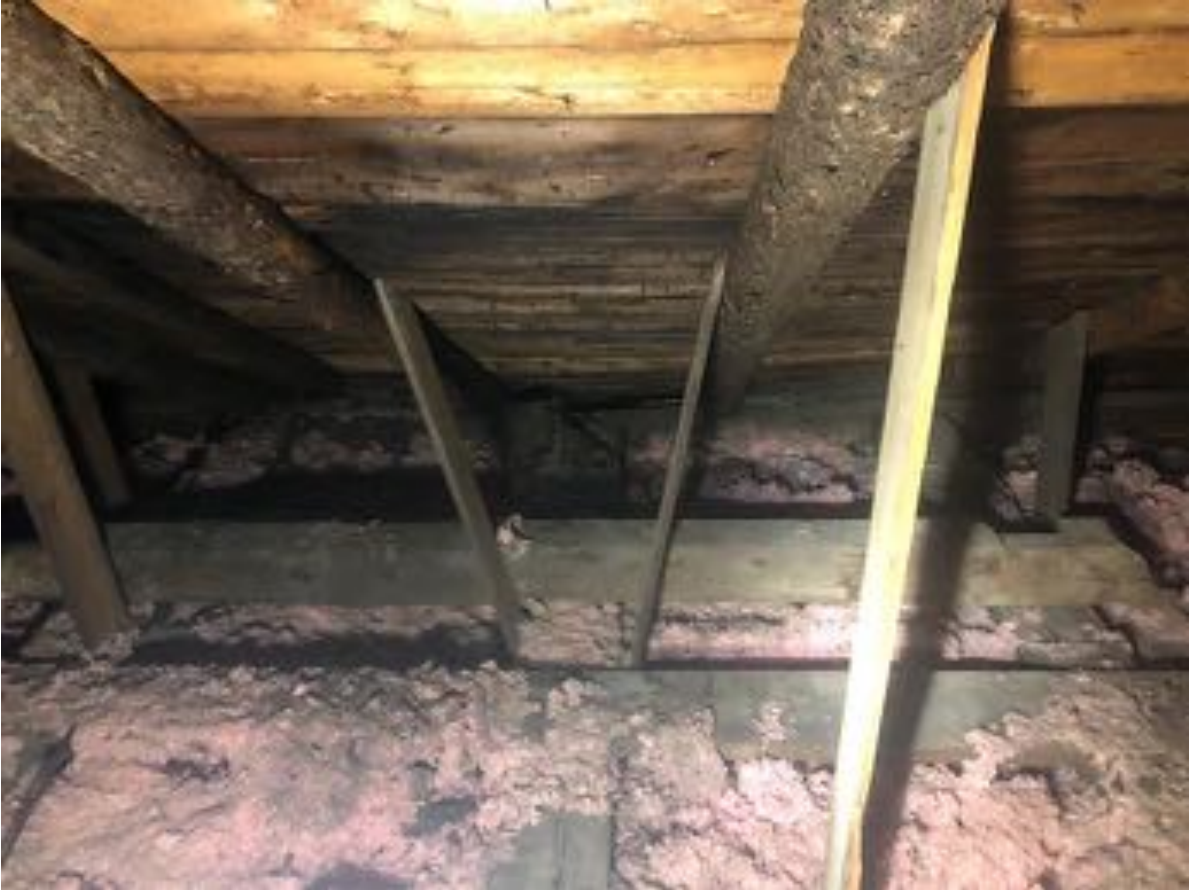
Tie beam number five (with number one being the road side, East gable) is rotted on both ends. In order to hold up the tie and support the ceiling someone installed a sleeper timber to sit on top of ties four and six and hang number five with a through bolt. In addition, they added cleats between the rafters and tie five presumably to hang it as well. Under any sort of load however, those will transfer weight down to the tie

beam five, which then hangs off of its neighbors. The dovetail joint does a moderate job of tying the walls together but it was not designed to carry any load beyond the ceiling weight. The sleeper that hangs tie five is actually transferring the roof load of the two rafters above it, as well as all of the ceiling weight for three tie beams, to ties four and six. It has already completely sheared the dovetail joint on the South end of tie beam six but it can be easily stabilized by installing a temporary shore post from the slab, up to the underside of the ceiling at the South end of tie beam five. Some exploratory work should be done to ensure that there is direct contact between the ceiling and the tie beam but presumably, since the tie is the joist, they are touching. This is not a long-term solution and should be monitored, as the slab and foundation are susceptible to frost and may have differential heaving and settling.

The sleeper between tie beams four to six, on the South side of the building. The sleeper sits on top of four and six and via a through bolt at tie beam five, hangs the middle tie, off of the other two. This weight on top of the tie beams is difficult for them to support; the dovetail on the ends of the ties is meant to tie the building together and be strong enough to support the ceiling. It was not designed to carry any roof load however, as it wasn't originally asked to do so. This repair transfers that roof load down through the two dovetails, instead of to the top plate, where the load path of the roof is meant to be.

The thorough, long-term solution will be to lift the building up from underneath the ceiling at first to replace the sills, repair the post bottoms and deal with the foundation. Then, the walls can be set down and the roof system lifted up with the same internal jacking setup underneath the ceiling, with false work added to transfer the support through the tie beams up to the rafters, allowing the top plates to be isolated and removed for replacement. It appears from the attic that the full length of both top plates will need to be replaced, but if there are significant portions that are still in good condition and can be scarfed into a new timber while remaining structurally sound, those portions should be saved. Any new timbers should match the originals in size, species and joinery and should be continuous timbers unless historic portions are incorporated as discussed. At this time, the roofing should also be removed at the middle of the building in order to access and likely replace tie beams #4,5,6 with new timbers to match the originals. The existing metal roofing should be removed, the roof sheathing investigated and replaced with new wide pine boards to match the original where necessary. The sheathing should then be covered with a high quality underlayment paper and new roofing material, preferably standing seam metal roofing, installed.

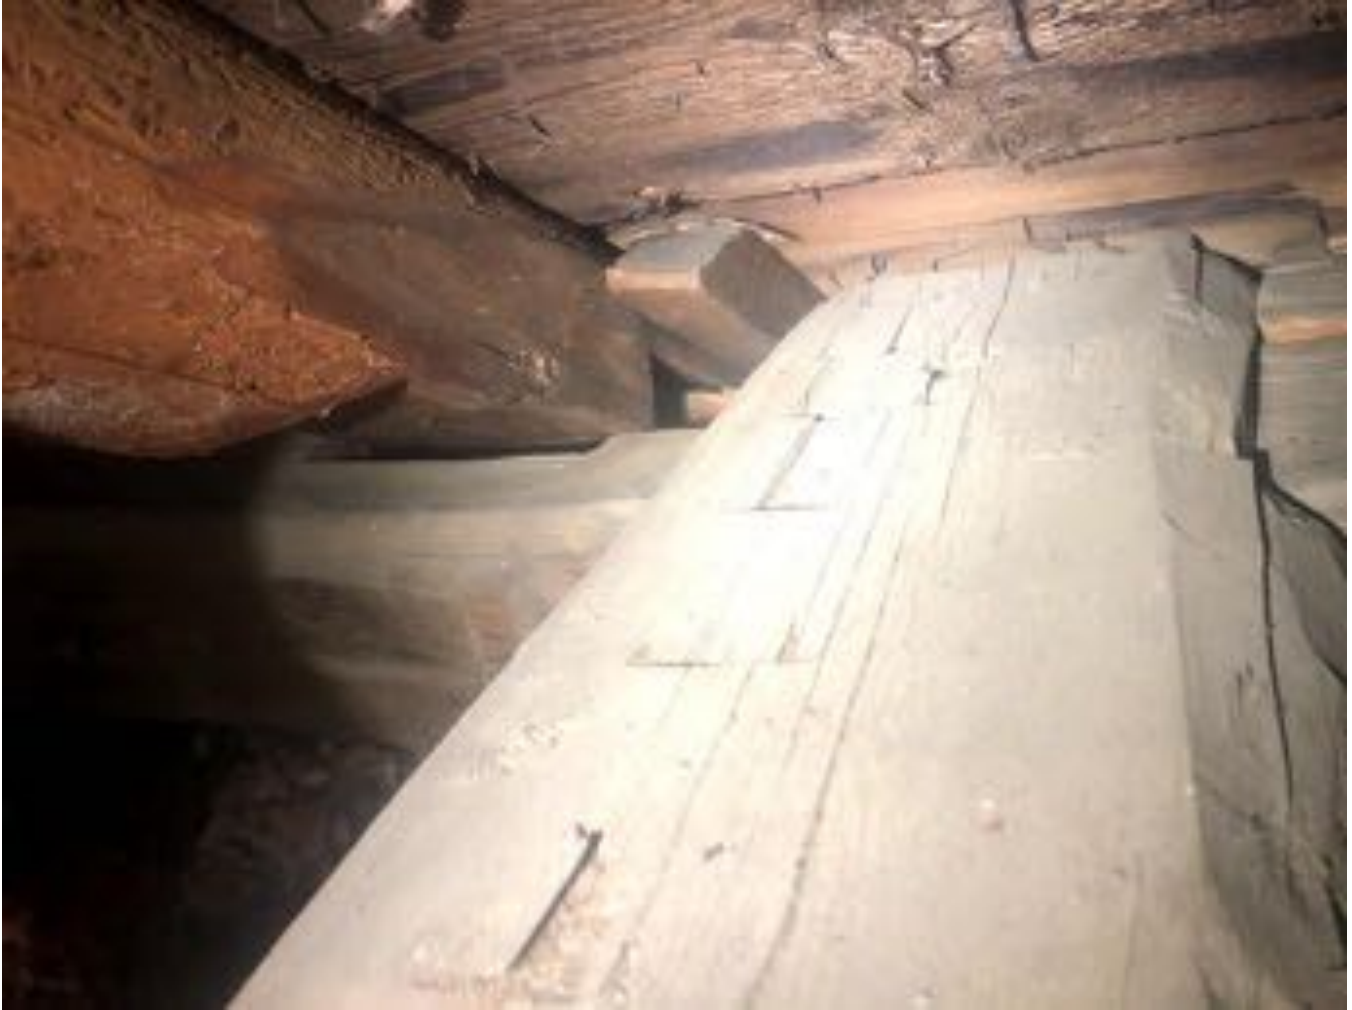
Half dovetailed tie beam end with rafter to plate connection shown as well. The step lap (two separate laps cut into the plate as the name suggests), usually has a step between the two that is square to the roof plane. Here, as is visible, the step is plumb. This is not a typical design but has been seen in other contemporaneous structures in Huntington and scattered around Vermont. With a pegged connection in the plate, which is square to the roof, the two angles work together to make uplift from any wind events nearly impossible.

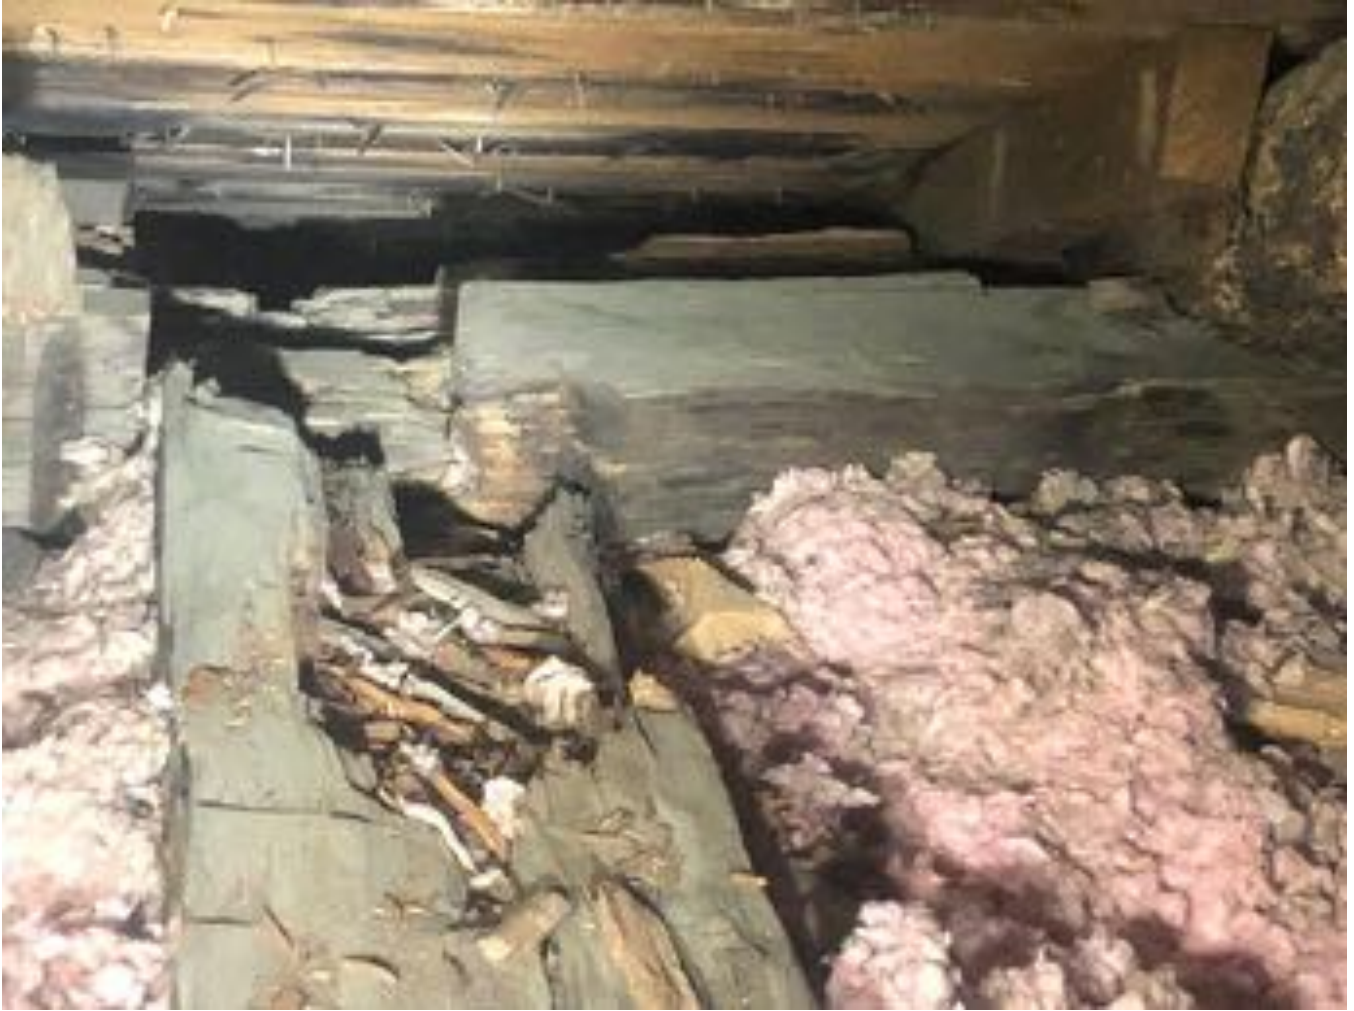
Severe rot at the South end of tie beam five.

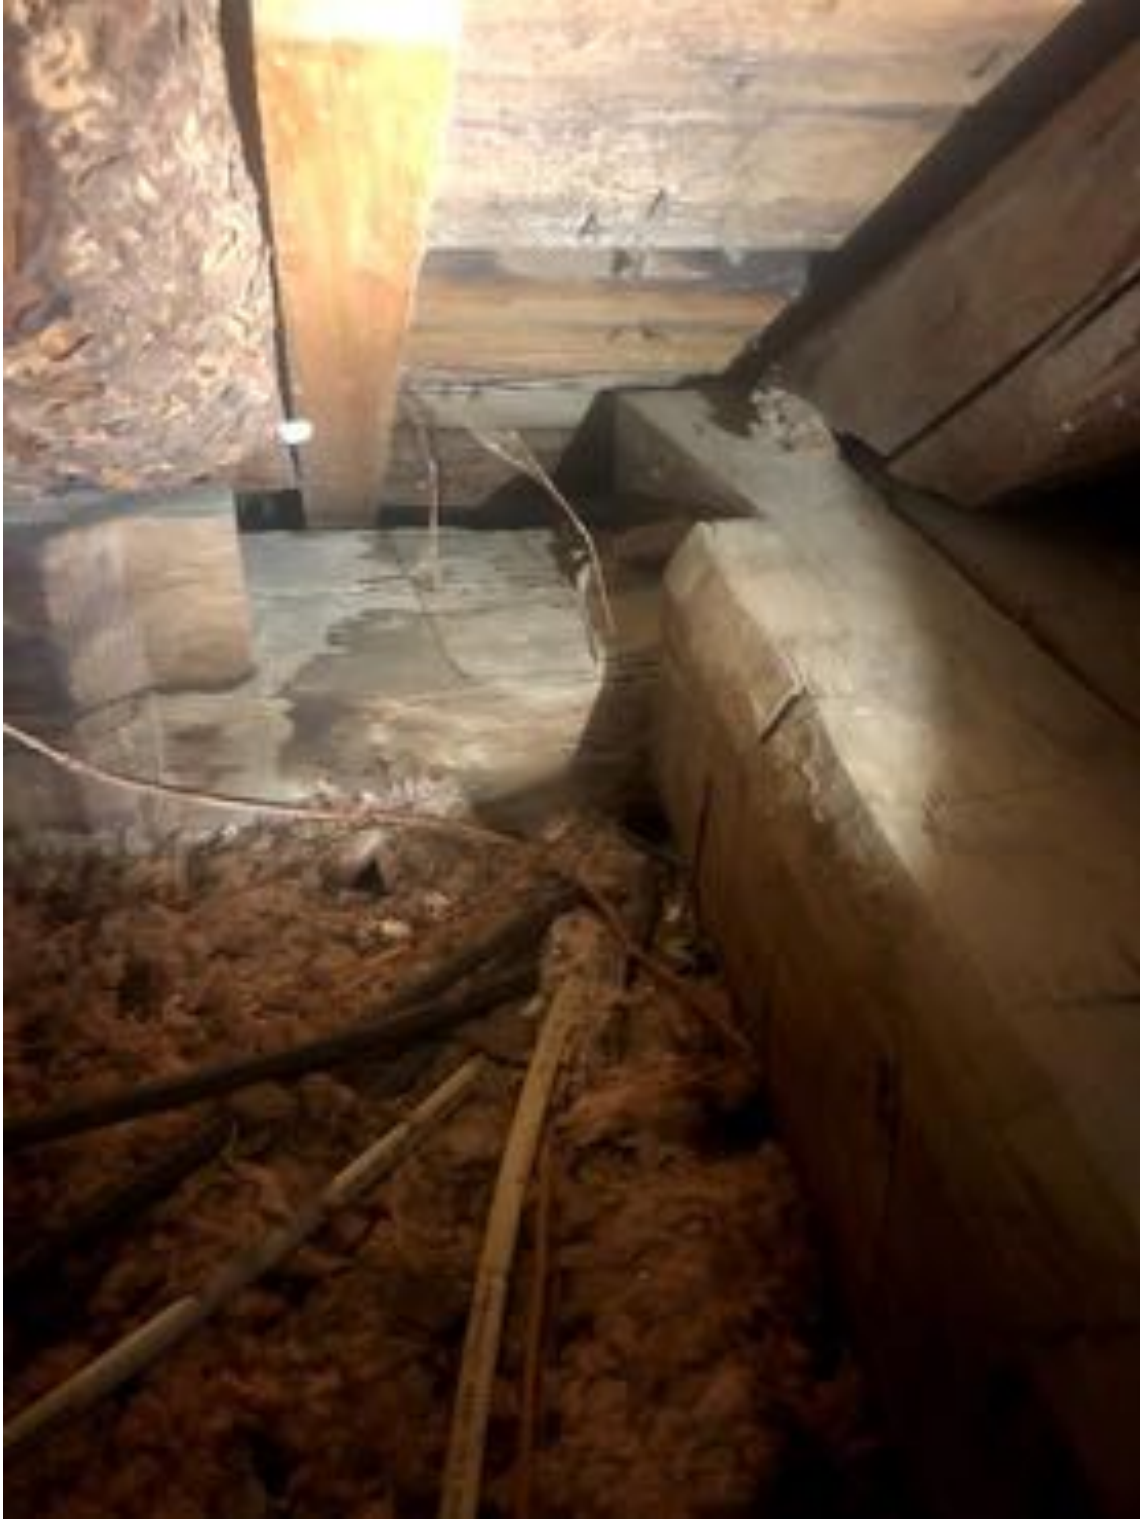
Another peculiar detail is found at the East end of the top plates, where there are half laps cut into the top of the two top plates, apparently for a beam other than the existing tie beam. At the beginning of the half lap, there is a rafter pair on the same layout as the rest of the roof, but shy of the gable wall plane by about a 10". On top of the tie beam, there is another pair of rafters, which make up the framing for the gable end. The redundancy of the rafters on layout and the curious nature of the exposed half lap, suggest that perhaps the top plates, with the step laps already cut, were salvaged from an earlier building and perhaps the tie beams added contemporaneously to the existing structure. Additional removal of the 1970's paneling on the interior might expose other errant joinery details in the top plates that could give some clues as to their origins.

The connection from tie beam to plate in the Northeast corner. The top plate has a half lap much larger than the width of the tie beam on both the North and South ends of the first bent. This is a peculiar detail, along with the rafter spacing, and suggests possible re-use of the plates as well, or simply a mistake in the joinery.
