**Conditions Assessment
of the
Old Firehouse/Freewill Baptist Church
Huntington Center**

Prepared by
Eliot Hays Lothrop
Building Heritage, LLC

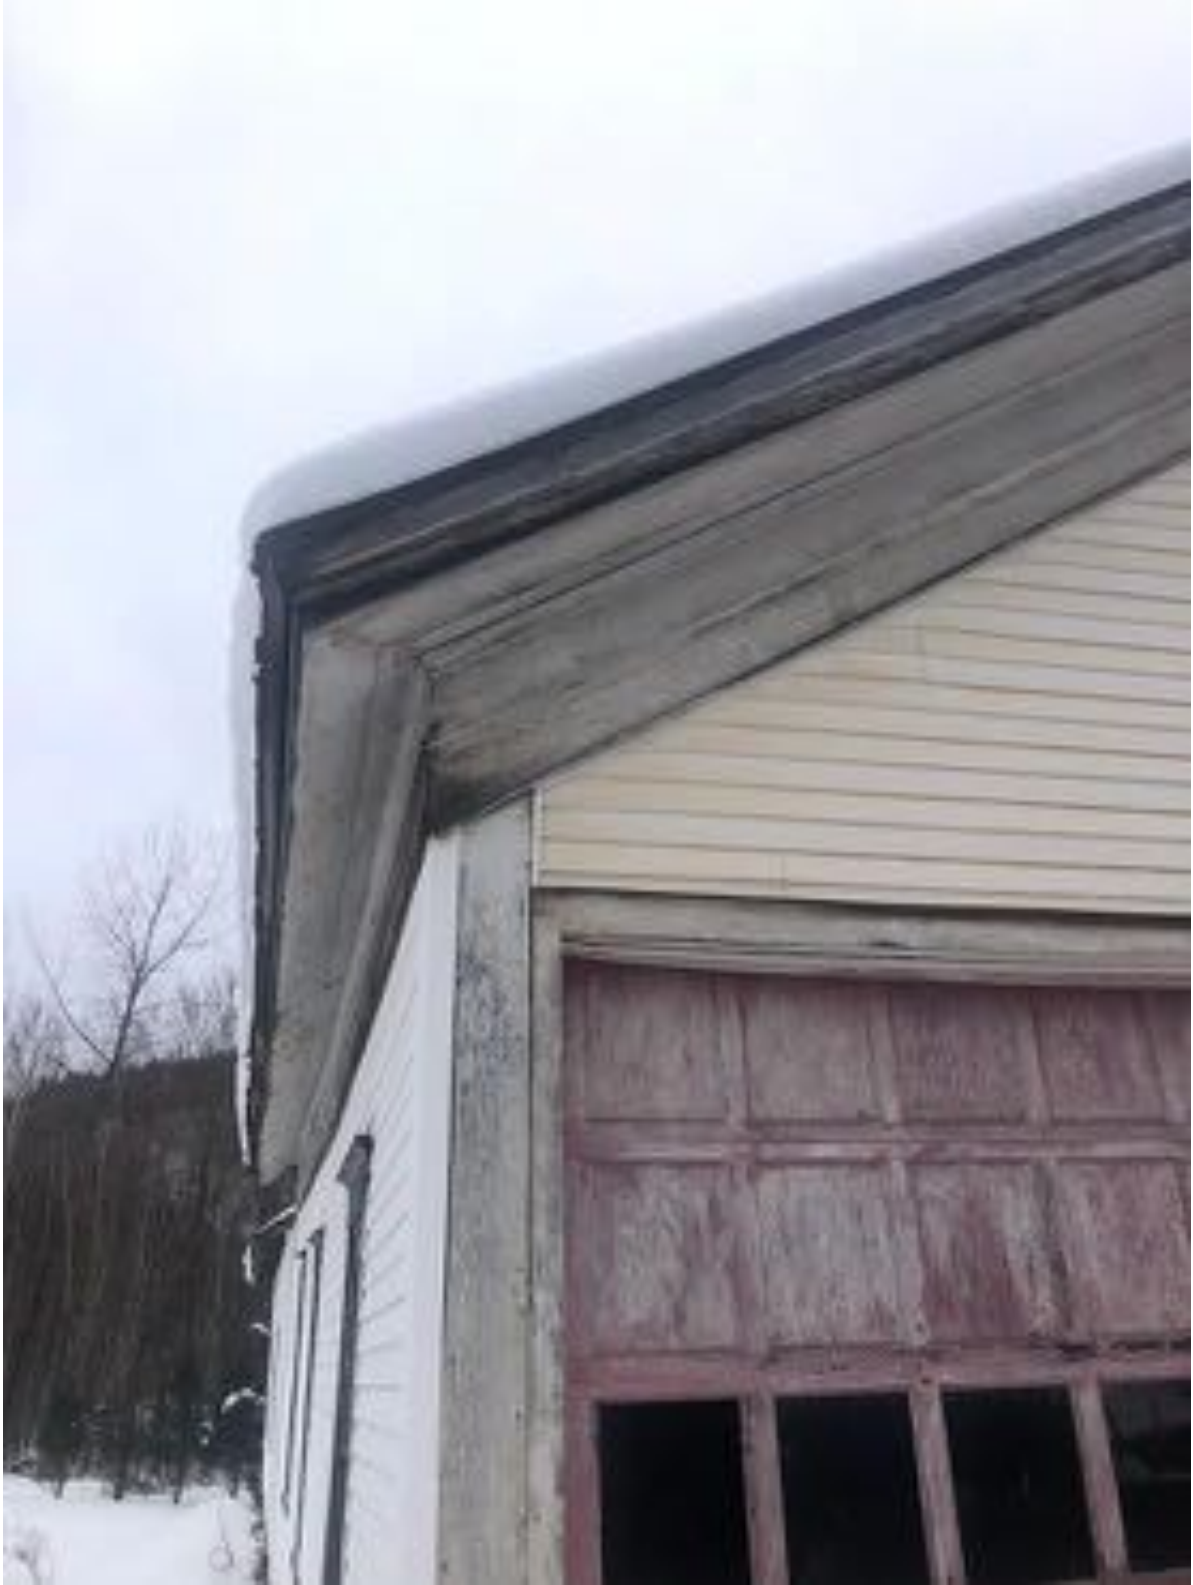
The Southeast corner roof trim detail, with a double frieze and deep soffit, adding to the simple vernacular elegance of the original building.

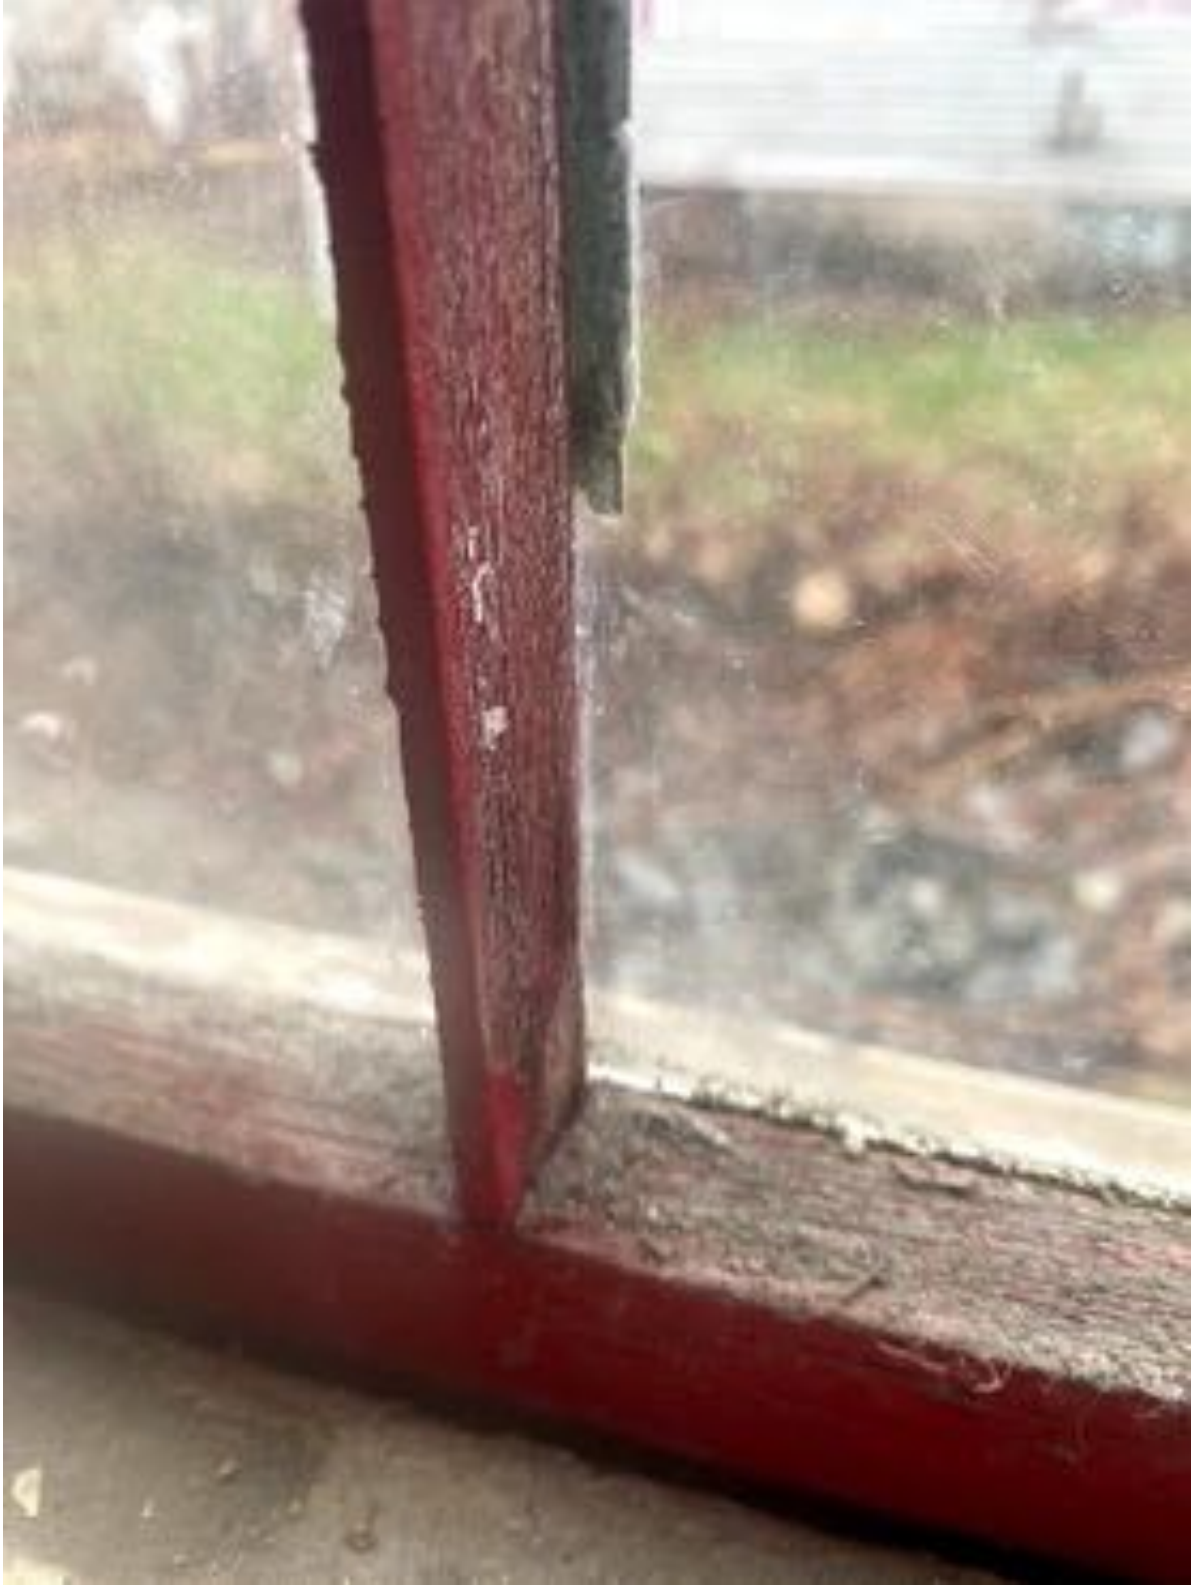
The slight concave curve of the muntins is typical for sash built from 1830-1850.

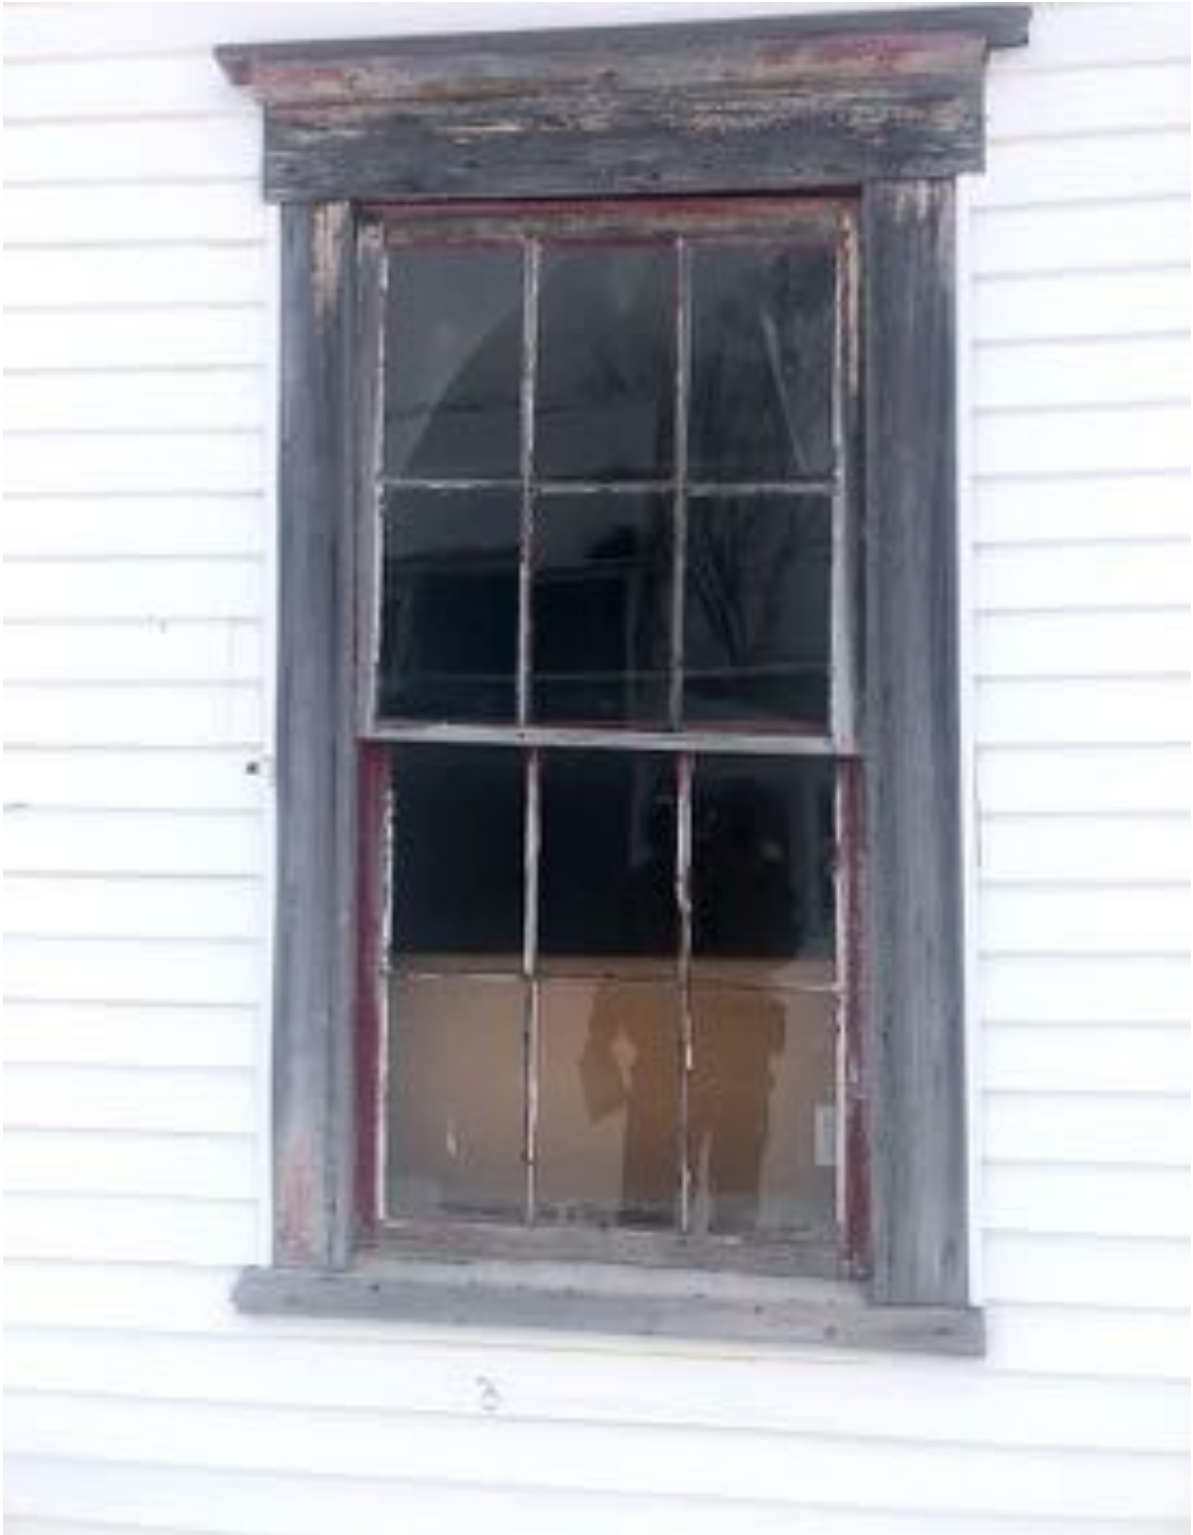
Six over six window on the North side of the building with the original trim and vinyl siding added. The existing woodwork is generally in good condition throughout and generally only in need of a thorough scraping and painting. Care should be taken to use precautions for lead in the paint removal process.

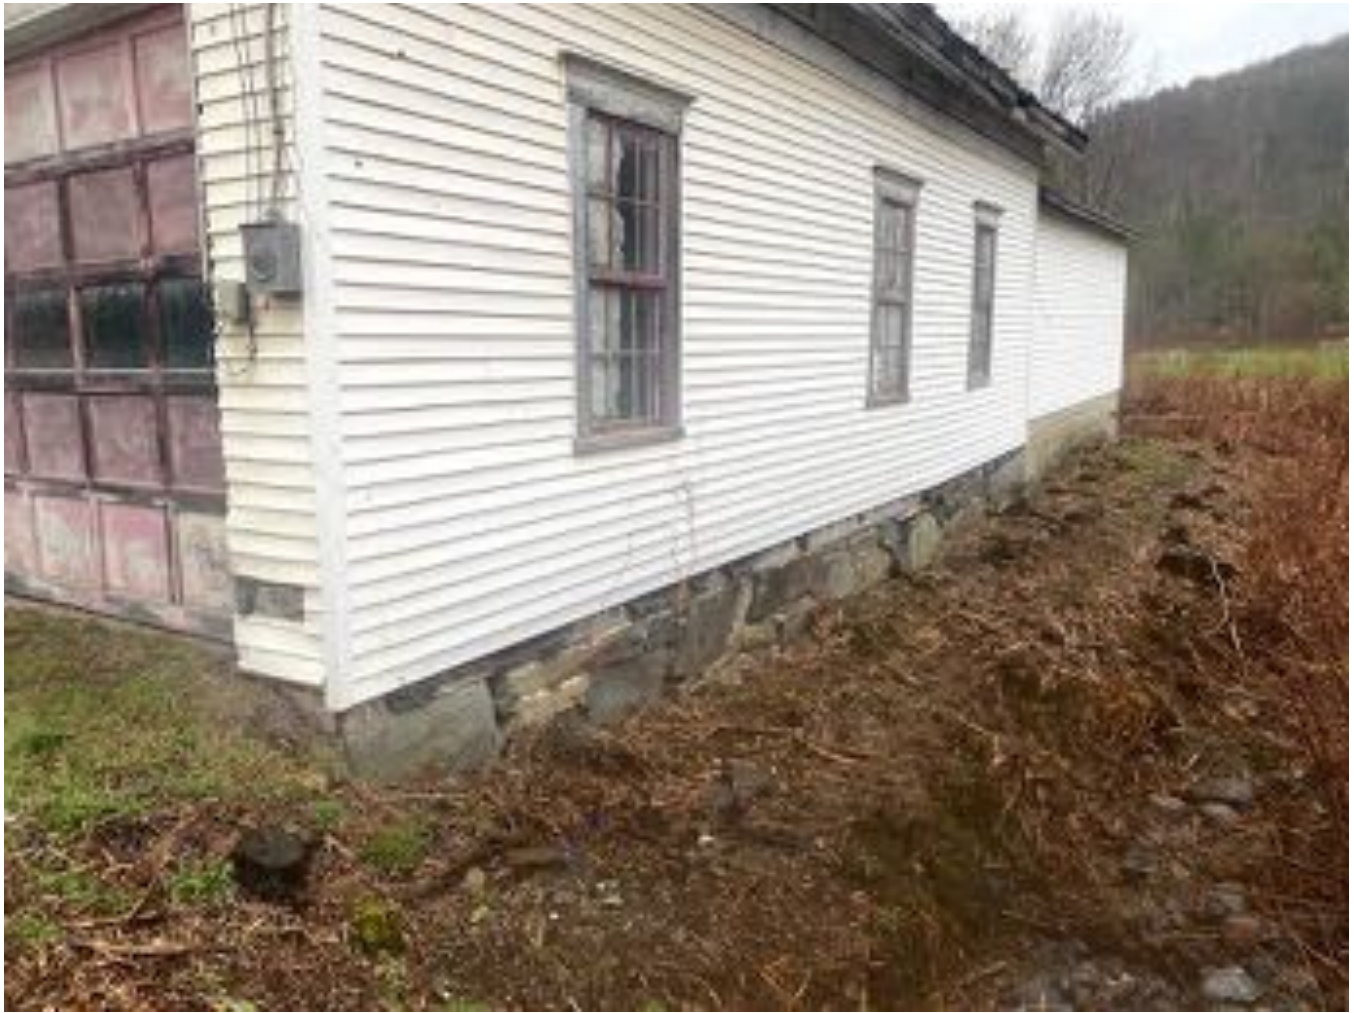
The North side of the building, with the only portion of the stone foundation still visible. To the North of the building is a small drainage stream. The banks of this stream are covered in Japanese Knotweed, which is currently being managed.

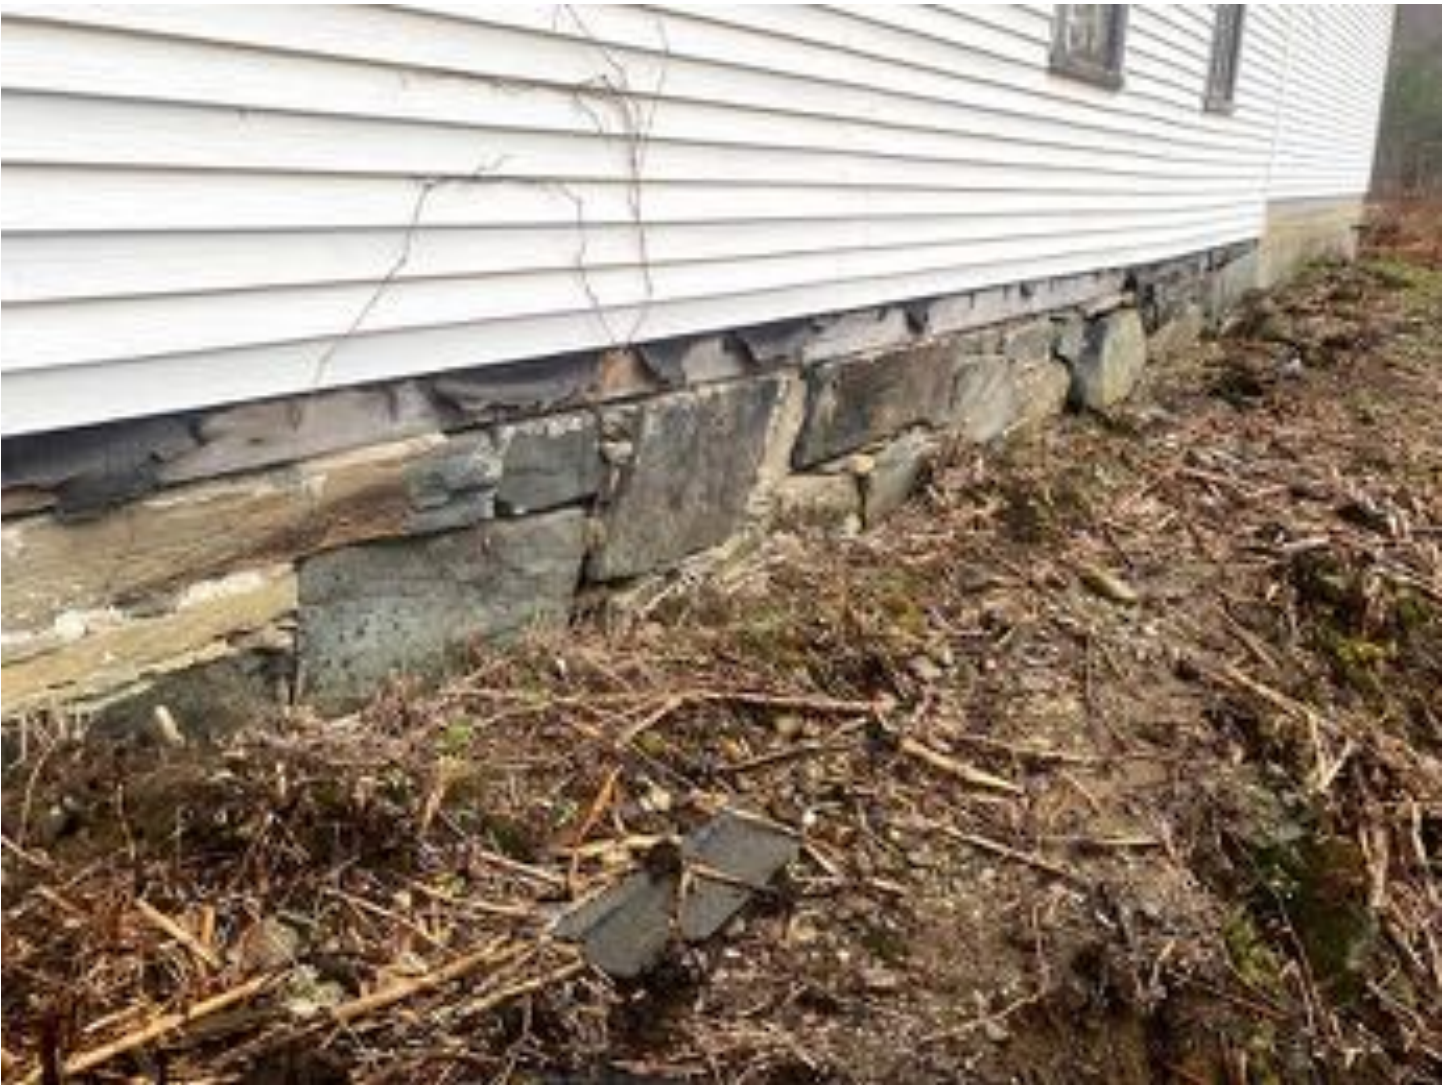
The foundation is only visible along the North wall, where 2-3' is exposed at the edge of the small stream that crosses the road, right alongside the building. The fieldstone foundation was dry-laid in its construction and then pointed with a lime-based mortar. Much of the mortar has weathered away as is typical with lime but portions of it still remain and an original sample could be gathered. Many of the stones have shifted and several of the larger ones are tipping away from the building. This condition will likely become accelerated, as it becomes easier for water to infiltrate behind the stones, heaving and shifting them through the spring freeze thaw cycle. On the East and South sides, the top of the foundation wall is below grade and not visible. This will present an issue for the foundation long term as the top of the wall should be higher than the road by enough of a height to allow positive drainage away from the building, especially as the road height continues to be built up. It would be advisable to add 1-2

The stone foundation on the North wall. A few of the stones have shifted and need to be reset but the majority of the stonework simply needs repointing. The original mortar was lime-based and replacement mortar should be mixed to match the original.

feet of height to the entire foundation when the building is lifted up to replace the sills. At that point, it might be most efficient to replace the frost wall portions of the foundation below grade with concrete and use the original stone above grade
